Maritime Helicopters

September/3rd Quarter 2018 Quality & Safety Notes

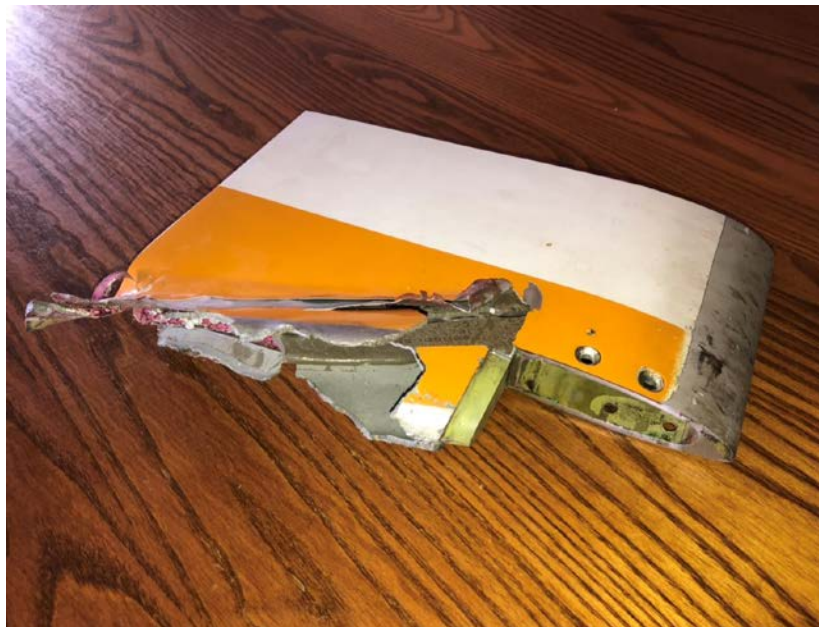
FIR 201815, 7/20/2018/1745: Bell 206 L4 (Blade Strike with Terrain)

Pilot was working with geologists in extreme Northeast Alaska in the Ignek Valley (East of Kavik Camp). With one geologist onboard, the pilot was repositioning in a steep sided valley (Google Earth the Ignek Valley folks, it is steep). With a quartering, gusty tailwind from one valley wall, the pilot was attempting to land at the bottom of the gully. In the investigation interview afterwards, the pilot admitted to knowingly attempt the landing closer than the 12' rotor clearance limit in our SOP.

Both rotor blades contacted the gully slope and caused the following damage in addition to the blade (because of sudden stoppage). Replaced: Main rotor hub, mast assembly, input driveshaft, freewheeling unit, and engine gearbox. Parts removed, Non-Destructive Inspected (NDI) and installed: Engine mounts, all tail rotor driveshaft segments, hangar, and disk packs. Total Cost of the Incident: Approximately \$630,000.00

A landing in very remote areas and impromptu landing areas is one of the most difficult things we do in this business. But a landing area isn't a landing area if it doesn't meet some very simple criteria. Slope within aircraft limits, landing direction favorable with the wind, good landing surface, no dangerous debris and adequate rotor and tail rotor clearance all need consideration. So if a landing area does not meet these criteria, it isn't a landing area. Our customers pay for safe landing area decisions.
