# COMMERCIAL ENGINE BULLETIN

**Detroit Diesel Allison**

## ENGINE, TURBINE EXHAUST COLLECTOR INNER CONE--MODIFY

REFERENCE:       CW 3033

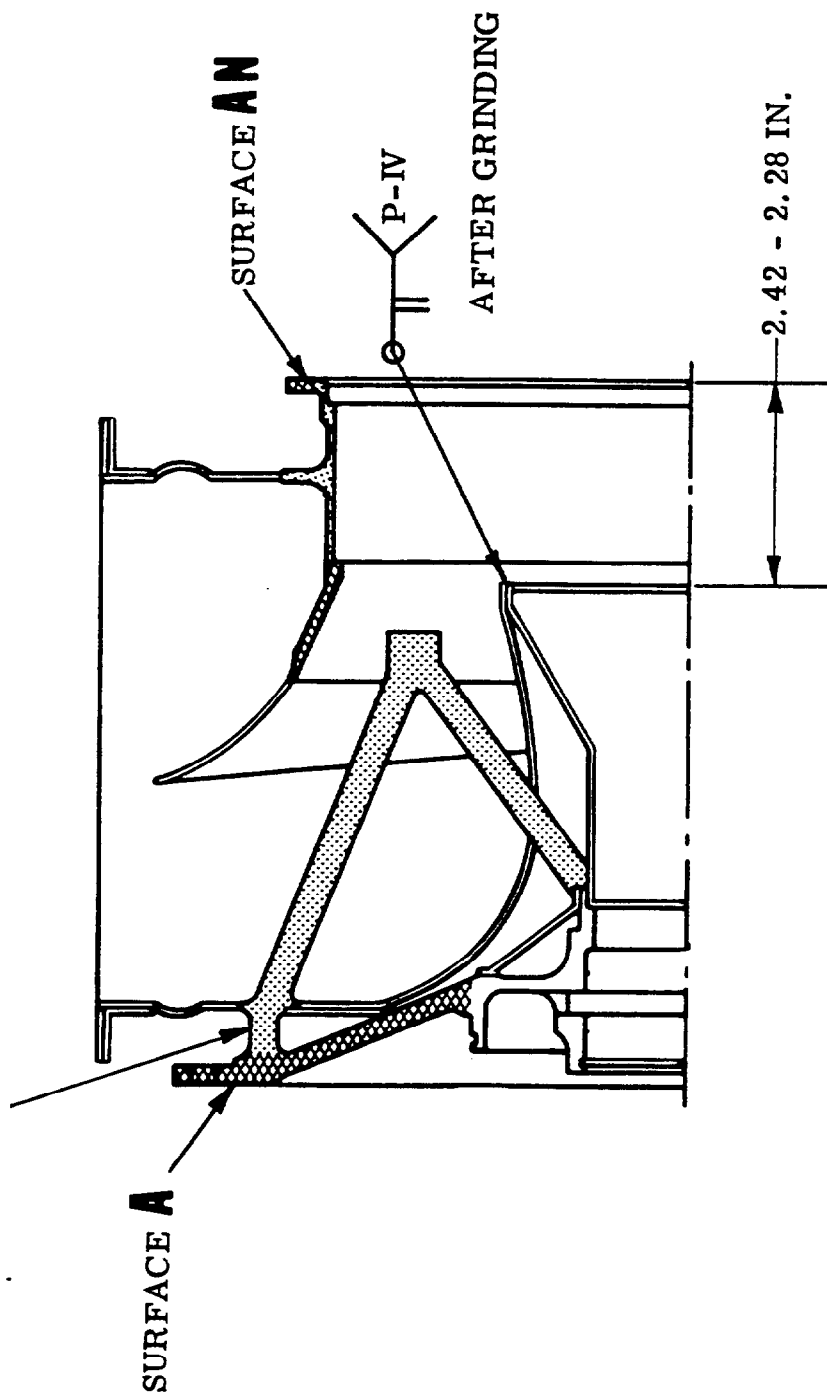
FIGURE 1

**REASON:** It is possible for the fourth stage wheel to contact the upstream edge of the -7 detail sheet metal inner cone of the exhaust collector under adverse tolerance stack conditions.

PARTIAL SECTION VIEW  
TURBINE AND EXHAUST COLLECTOR SUPPORT

**DESCRIPTION:** The upstream edge of the -7 detail sheet metal inner cone of the exhaust collector is machined to obtain an increased minimum locating dimension from the power turbine support mounting flange.

- 1.0 Modify and reidentify affected P/N 6893075, 23001996, 23004240 or 23004509 Support Assemblies, Turbine and Exhaust Collectors.  
Refer to Figure 1.
- 1.1 Ensure that support assembly, turbine and exhaust collector to be modified has passed the inspection criteria in the Overhaul Manual and is in fit condition for further service and to be modified.
- 1.2 Machine or hand grind the upstream edge of the -7 detail sheet metal inner cone to obtain the increased minimum locating dimension as shown in Figure 1. Reweld using inert gas arc, without filler rod.
- 1.3 Reidentify modified Support Assemblies, Turbine and Exhaust Collector by adding the suffix "CEB 72-3044" to the part number and any existing suffixes per AS478-2D1.
- 2.0 Record compliance with 250-C30 CEB 72-3044 in the Engine Log Book, Turbine Assembly (pink pages), Modification Record, Part III.

REIDENTIFY MODIFIED EXHAUST COLLECTOR  
BY ADDING "CEB 72-3044" SUFFIX TO PART  
NUMBER AND ANY EXISTING SUFFIX PER  
AS478-2D1
