# Maritime Helicopters

## 2<sup>nd</sup> & 3rd Quarters 2023 Quality & Safety Notes

## First Quarter 2023 Quality & Safety Notes

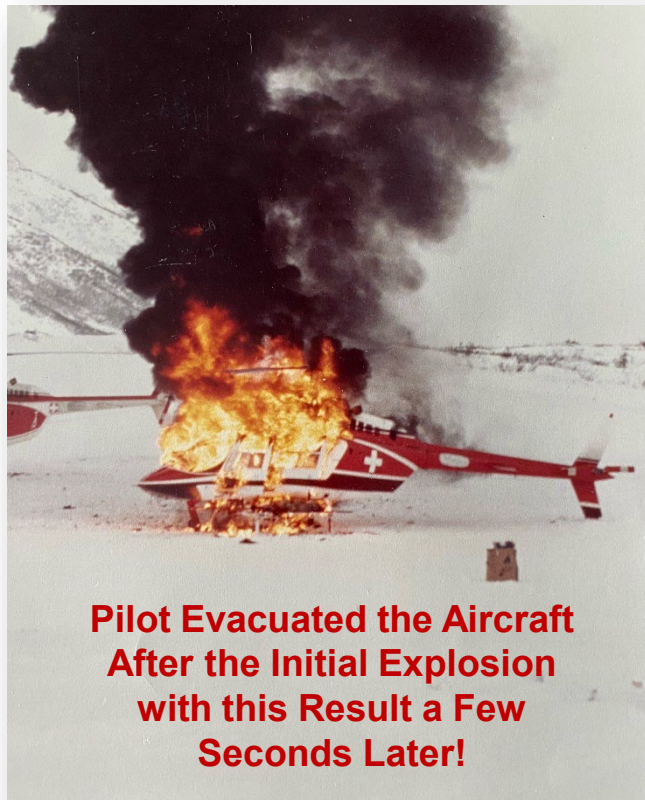
# Within Seconds....

**Pilot Evacuated the Aircraft  
After the Initial Explosion  
with this Result a Few  
Seconds Later!**

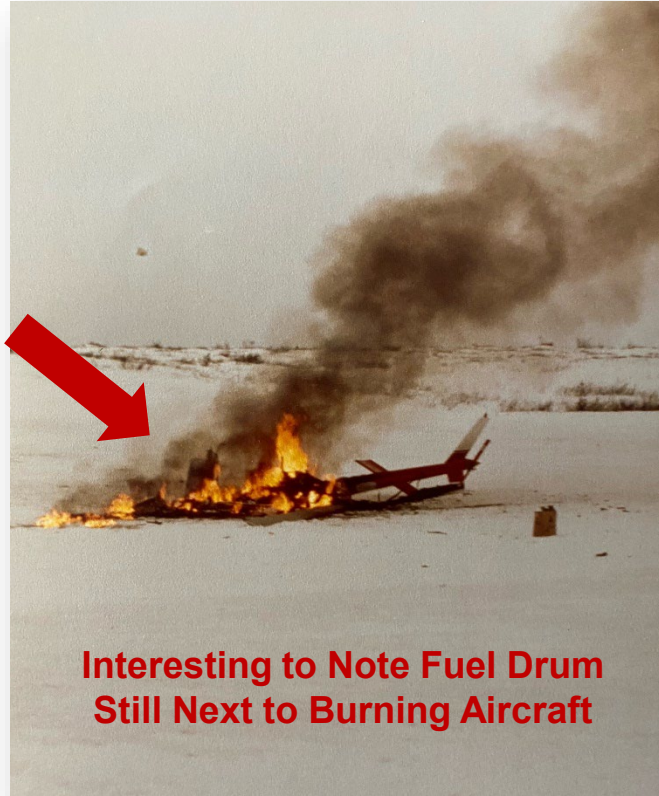
# Within 15 Minutes

Interesting to Note Fuel Drum  
Still Next to Burning Aircraft

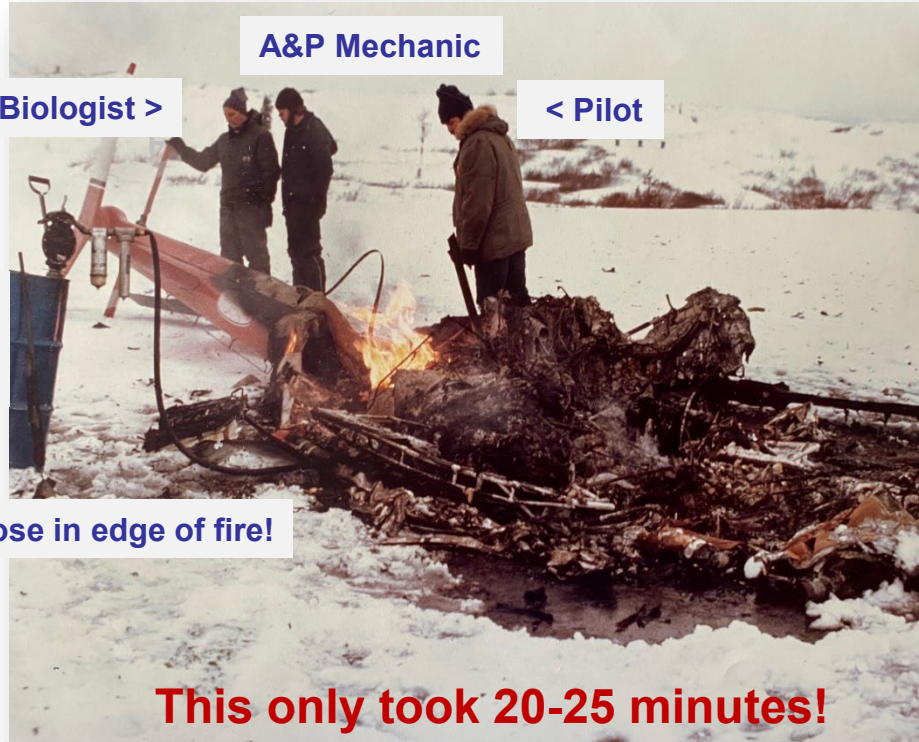
# Finally the End Product!

- Hand-pumping with particle filter & Go-No-Go fuse
- No grounding and/or bonding between drum & A/C
- Jet-B with its high volatility (65% gas, 35% kerosene)
- **Electrostatic Discharge created when:**
  - Fuel passing thru nozzles, hoses, filters, fuel water separators, then falls or splashes into fuel tank
  - Greatest potential for electrostatic discharge between refueling nozzle & aircraft exist w/no bonding (Safety Hotline May/June 1998)
- Remember it is Cold and Dry
- Freefalling fuel from nozzle to bottom of tank w/ low quantity and high volatile vapors results in ignition, explosion & fire

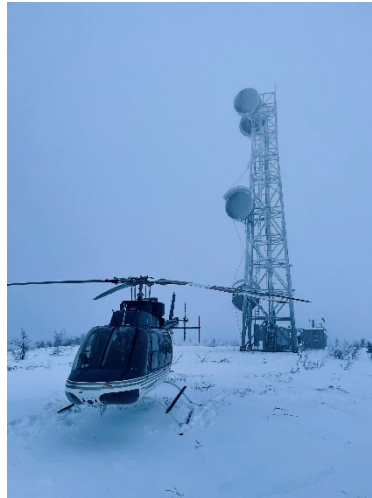
**3. When landing by tall buildings or antennae, make sure you land where you are going to get whacked by flying hoarfrost, breaking off from above! (see photo above)**

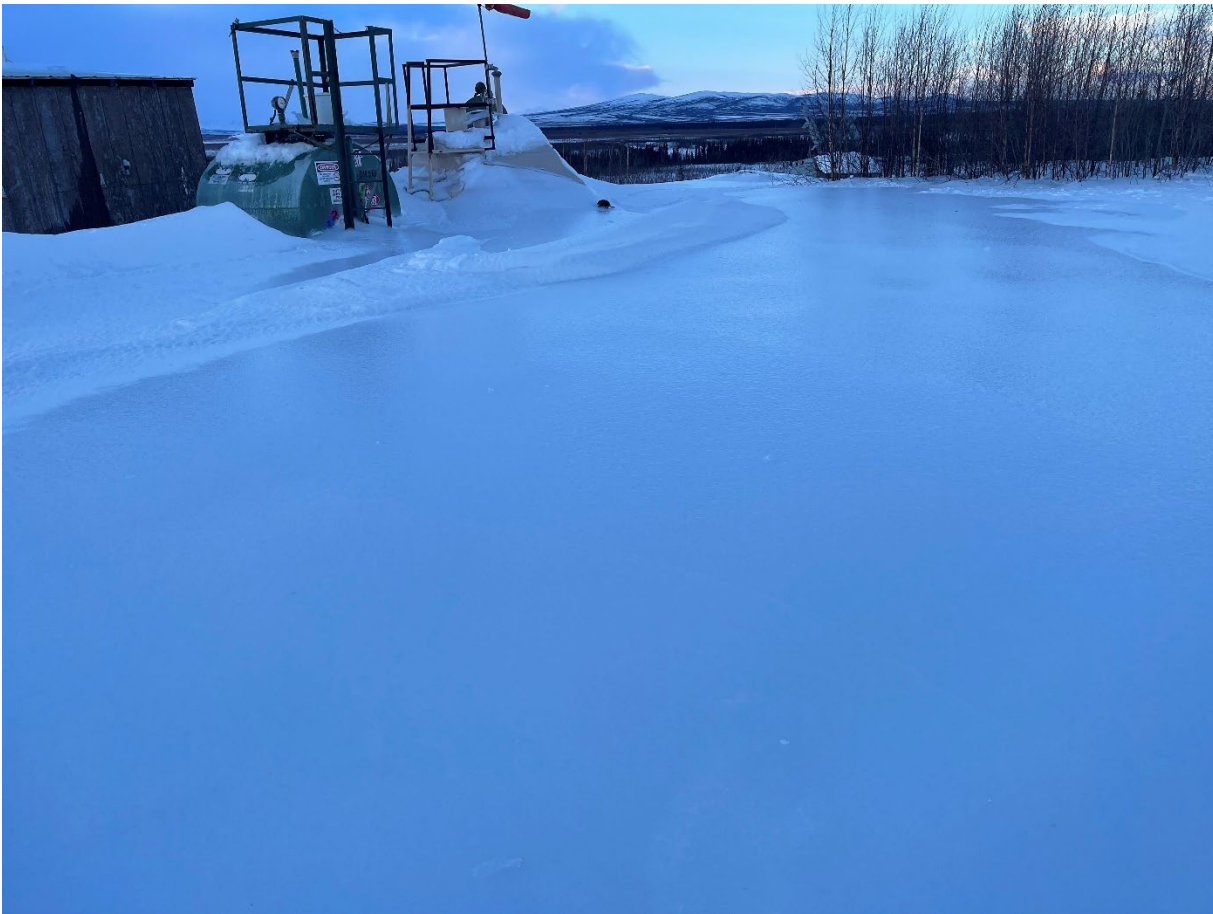
Just this Monday, I went out to a customer site where the snow was three feet deep with two inches of ice on top of the snow. This is a perfect condition to get into dynamic rollover! I landed a few times to crush the surface ice in case that icy top would stick me in the snow underneath as I picked up. Then, after landing, I stomped the snow down around the landing skids to break up the ice. When I took off later, I came up **EXCEEDINGLY** slowly to ensure the skids were clear of the ice layer. All's well that ends well. The other choice would have been to NOT LAND HERE.

Alaska wildlife note; there is an Arctic Ground Squirrel in this photo, trying to walk across the ice with great difficulty.
