Maritime Helicopters

JULY 2016 Quality & Safety Notes

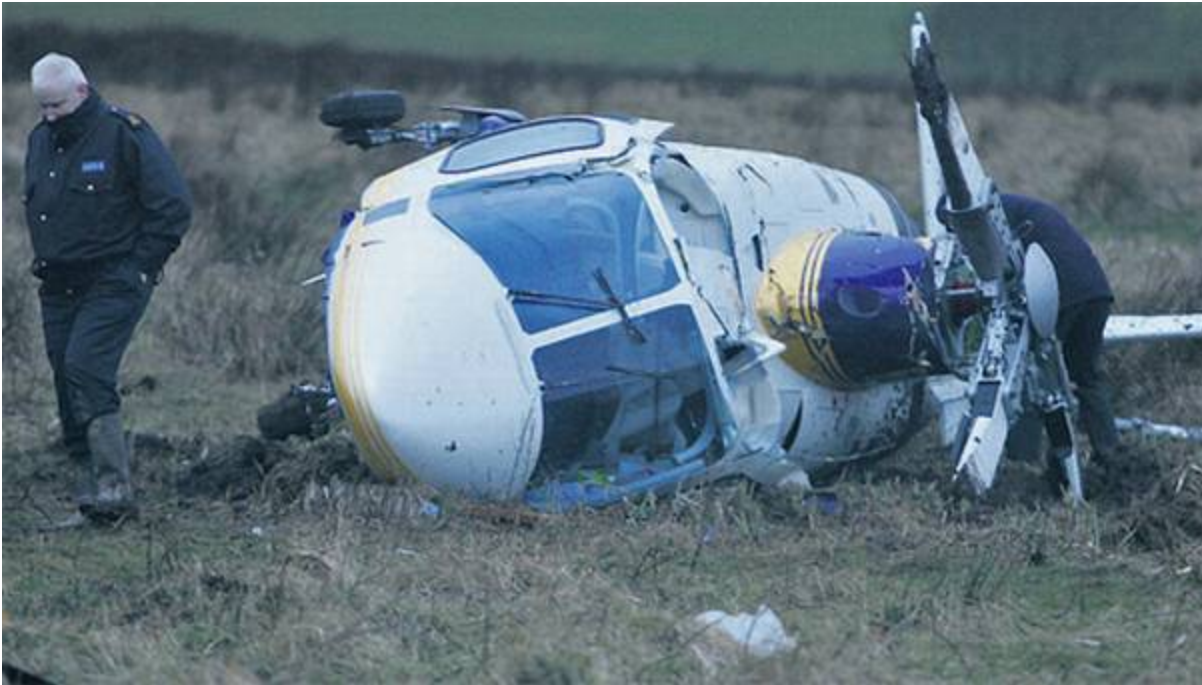
Okay, so we have a wet spongy surface, with uneven grasses and moss, possible open water, and unknown hidden sticks and branches that could reach out and introduce a helicopter to dynamic rollover faster than you can say “rolling moment of inertia”.

British rollover accident in a bog similar to our muskeg.

So other than awareness of muskeg characteristics, what can we do to avoid the kind of incident pictured above? 1. You could find someplace else to land. Asking a customer to walk through some muskeg is better than asking them to walk home. 2. Review the conditions of dynamic rollover. 3. Ensure your bear paws or tundra boards on your skids are in good shape to keep you from sinking into these saturated areas. 4. **You could reread number 1.**

PLEASE! Also remember that if you are sinking into muskeg, your tail rotor will get a lot closer to the ground!
